HVAC STUDY

HVAC Assessment and Professional Judgement of
the Existing Conditions of the Massillon Municipal
Government and Justice Center

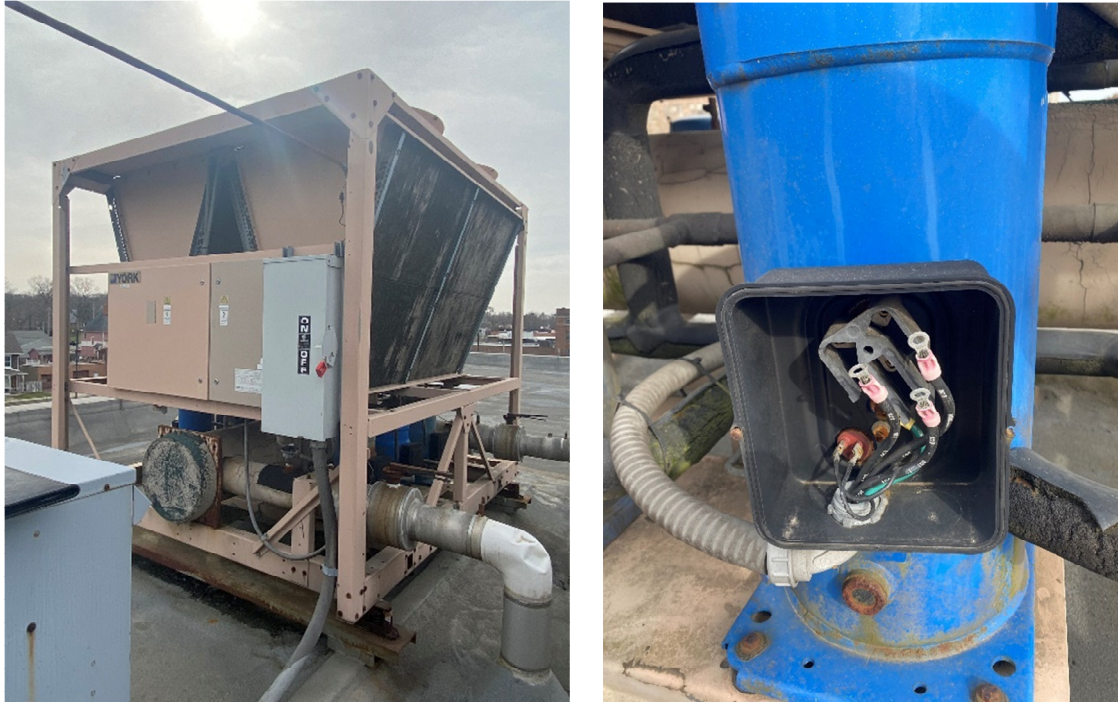
Chiller #1 – all coil fins are bent over. This was probably due to a hailstorm or coil pressure washing at some point. With the coil fins damaged, the unit is not able to reject heat and is not as efficient. One of the compressors is missing an electrical cover. At a minimum, the fins will need to be straightened with a fin comb.

Chiller #2 – Same condition as chiller #1. One compressor is disconnected (most likely failed and needs replaced).

Figure 1 York Chiller on roof. Note damaged fins on coils. Second picture shows missing electrical cover and disconnected compressor.

According to ASHRAE, the air-cooled chillers can be expected to have an economic life of 20 to 25 years. At 21 years old, these chillers are at or near the end of their expected life. These units can last longer with continued maintenance, but we have reached the point in their service life where it will cost more to maintain the units than to replace them with new.

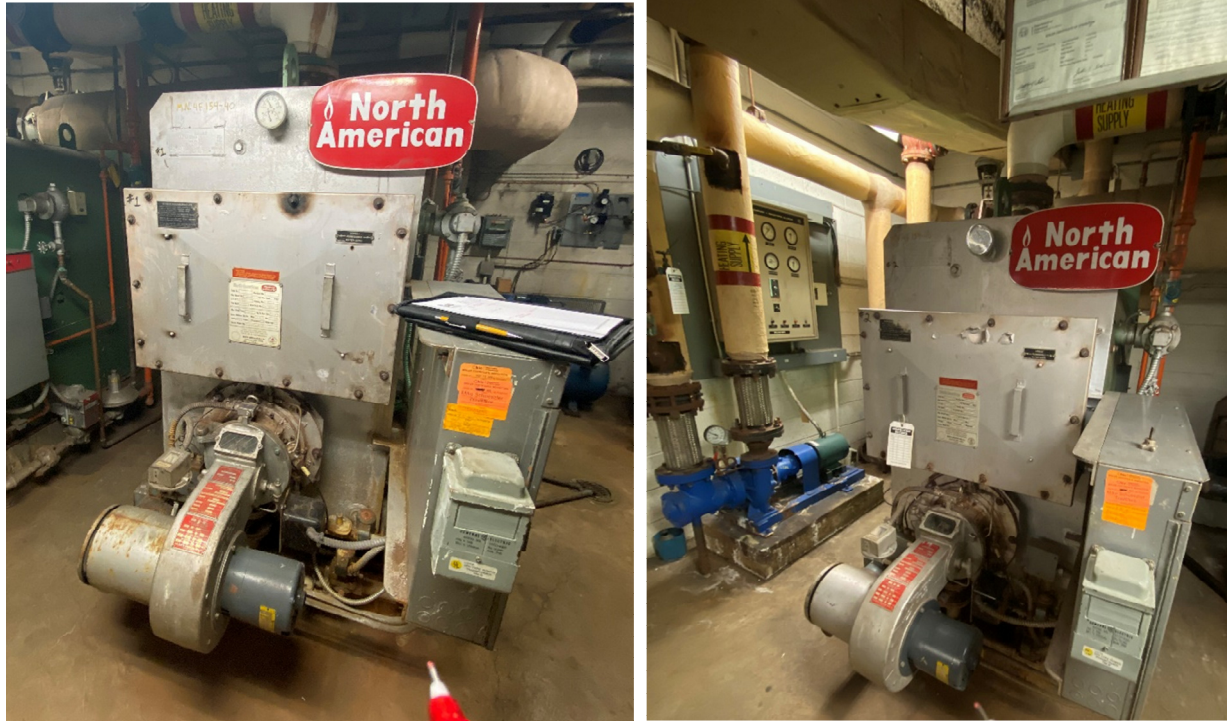
The existing boiler plant appears to be original to the building and consists of two cast iron boilers. Manufactured in 1975, these Burnham boilers are 1.5 MBTU is capacity and are equipped with North American burners of the same vintage. These burners have the dual capability of burning either natural gas or fuel oil, however the fuel oil piping not connected. The fuel oil option was most likely a redundant fuel supply in case of a natural gas interruption, but probably was not used or seldom used in its 46-year-old life. The boilers appear to be in good operating condition. According to ASHRAE, boilers of this style have an economic life of 35 years. Having exceeded the expected life by 11 years, these boilers are due for replacement.

Boilers of this vintage were approximately 75% efficient when new. Due to its age, it is most likely around 65-70% efficient. Today, modern hot water boilers range in efficiency from 92 to 98% and are equipped with microprocessor controls to match the load of the building more accurately. A significant natural gas savings would be realized by replacing these boilers with new.

Figure 2 Existing Heating Hot Water Boilers.

- Municipal Bldg - Demolish existing heating hot water boiler and associated pumps and replace with new. Possibly replace the heating hot water piping if the interior of the piping is found to be in poor condition. This could be a standalone project.

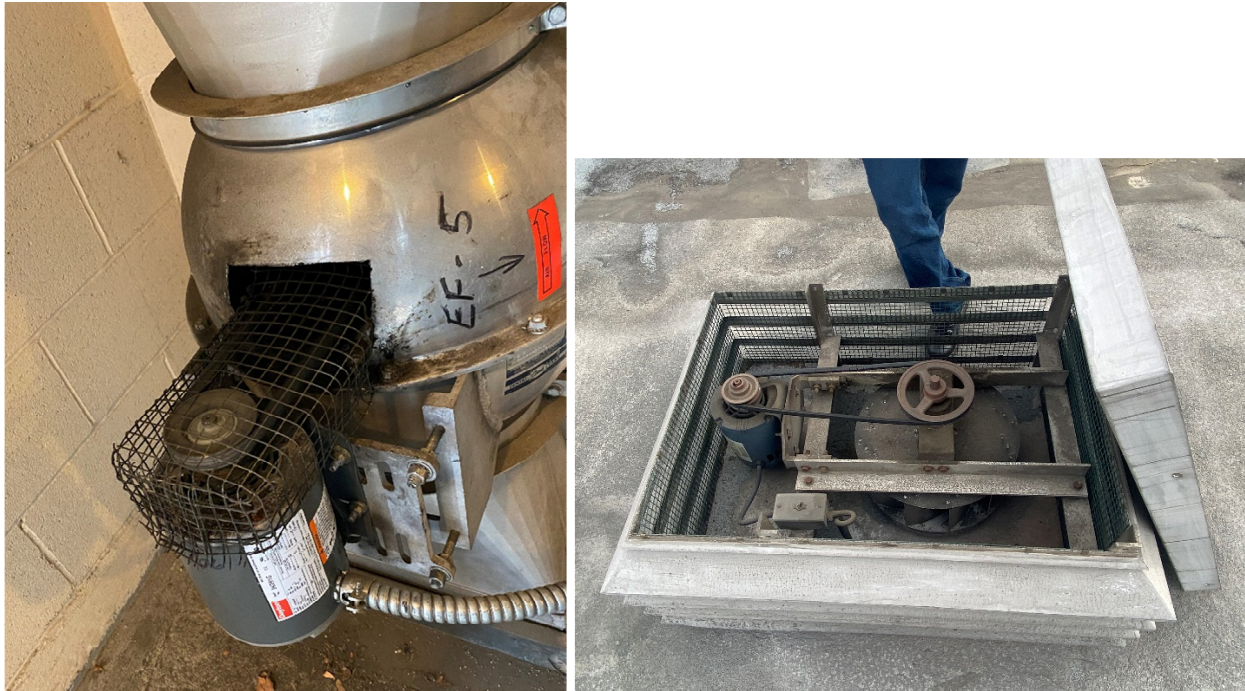
EF-5 – This fan is located inside of the penthouse on building B and serves the second-floor restrooms in building B. The age of this fan is not known, but it appears to be original. The motor replaced in the fan at some point and the belt opening on the fan shroud was enlarged. The belt guard is missing, and a new guard was fabricated out of wire mesh. This should be replaced with a new belt guard that is OSHA compliant. This fan is in serviceable condition.

The condition of these fans ranges from serviceable to poor. According to ASHRAE, the economic life of these exhaust fans is 15-25 years depending on type. All these fans have greatly exceeded their expected life and are due for replacement.

Figure 3 Exhaust fans. Note belt guard on EF-5 in the picture on the left.

- Both buildings – Demolish the existing exhaust fans and replace with new equipment. These exhaust fans to be resized per the current code prescribed exhaust requirements and unused areas deleted.

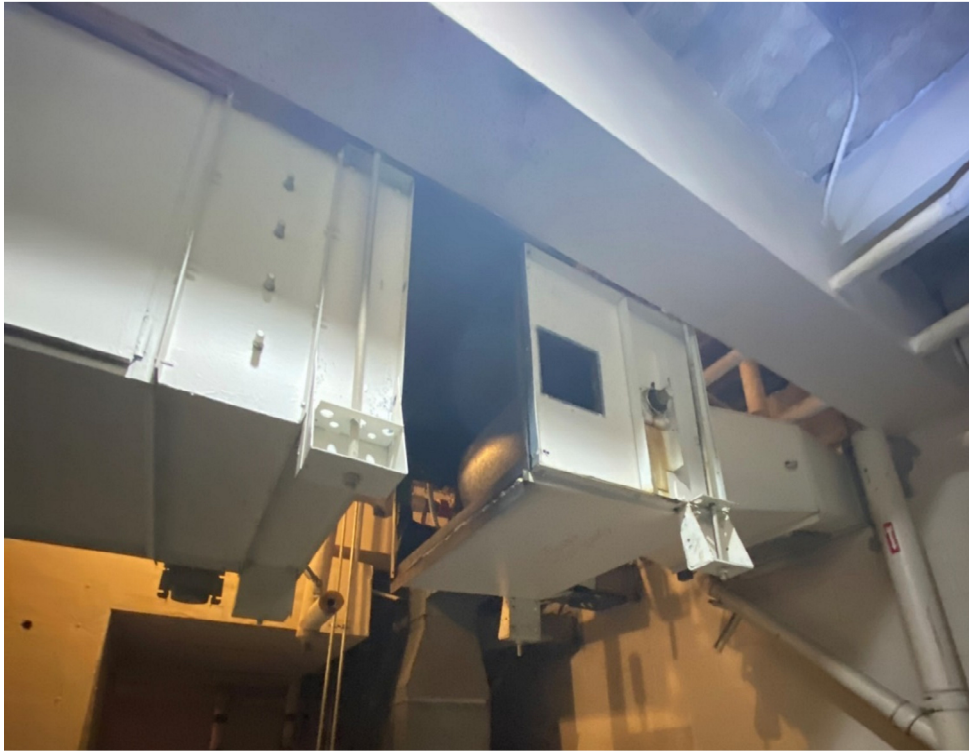
AH-1 – This air handling unit is located in the basement of building B. Part of the unit has been removed and the unit is no longer functional. This unit appears to serve the shooting range. If this area is still in operation, this unit should be replaced.

Figure 4 Air Handler tag AH-1. Note the missing section of the unit.

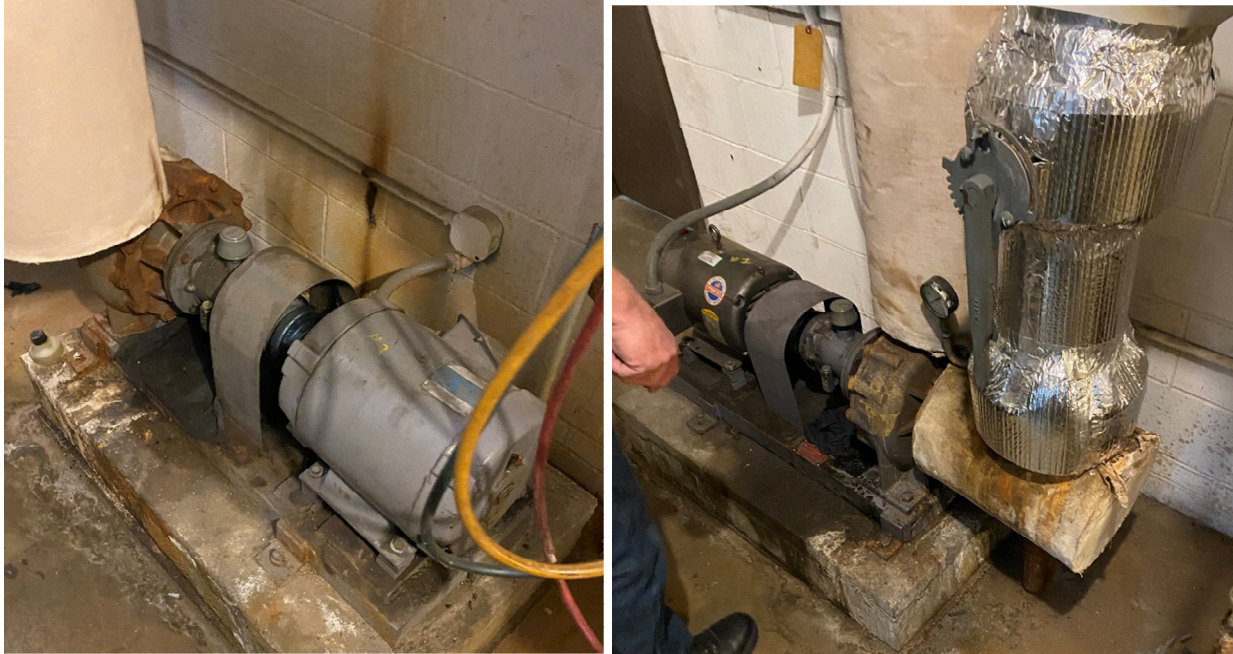
There are two chilled water pumps located in the penthouse and two heating hot water pumps in the boiler room. The chilled water pumps appear to be original to the building, but the motors have been replaced. The heating hot water pumps are newer and appear to be in good condition. According to ASHRAE, base mounted pumps, such as these, are expected to have an economic life of 20 years. The chilled water pumps are in poor condition and should be replaced when the chiller is replaced.

Figure 5 Chilled water pumps.

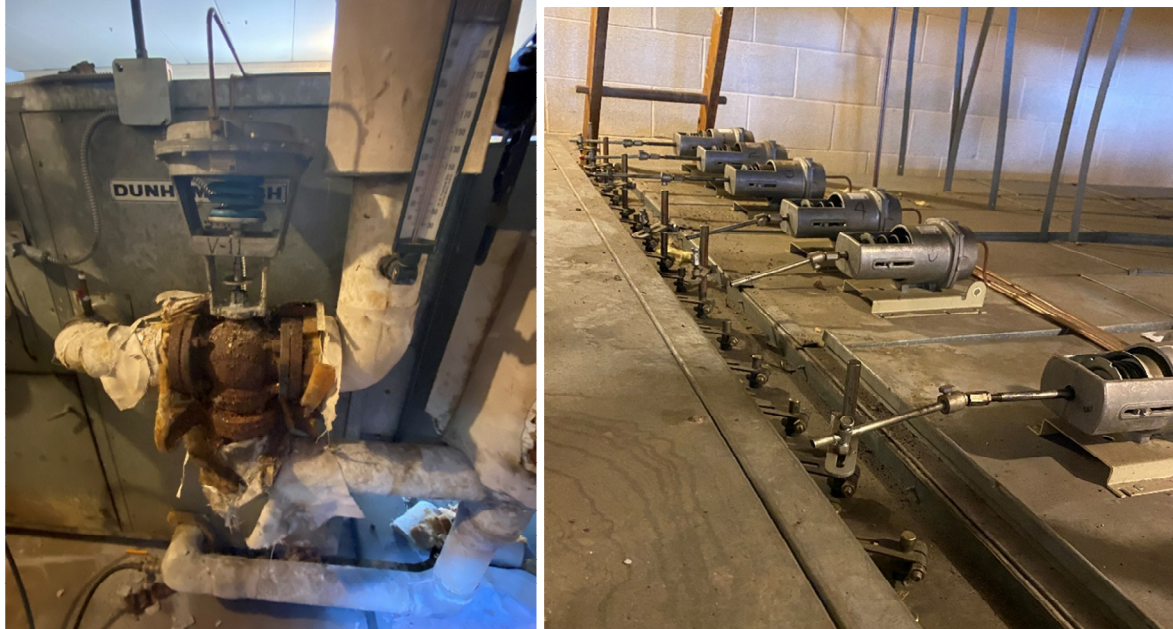
The temperature controls are a Barber Coleman pneumatic system that is original to the building. A newer Quincy air compressor in the boiler room powers the pneumatic system and appears to be in good condition. However, the remainder of the control system has reached the end of its life. Numerous air leaks from various devices cause the air compressor to operate more than it should to maintain air pressure in the air lines. Failed zone dampers are disconnected and either fixed in position or operated manually. Control valves are leaking, and thermostats are not able to control the zones accurately.

Figure 6 Control valve and zone actuators. Note disconnected actuator – second from right.

- Both buildings - Demolish the existing pneumatic temperature controls and replace with new Direct Digital Controls (DDC). A new control system will result in more efficient temperature control, energy savings and greater comfort.

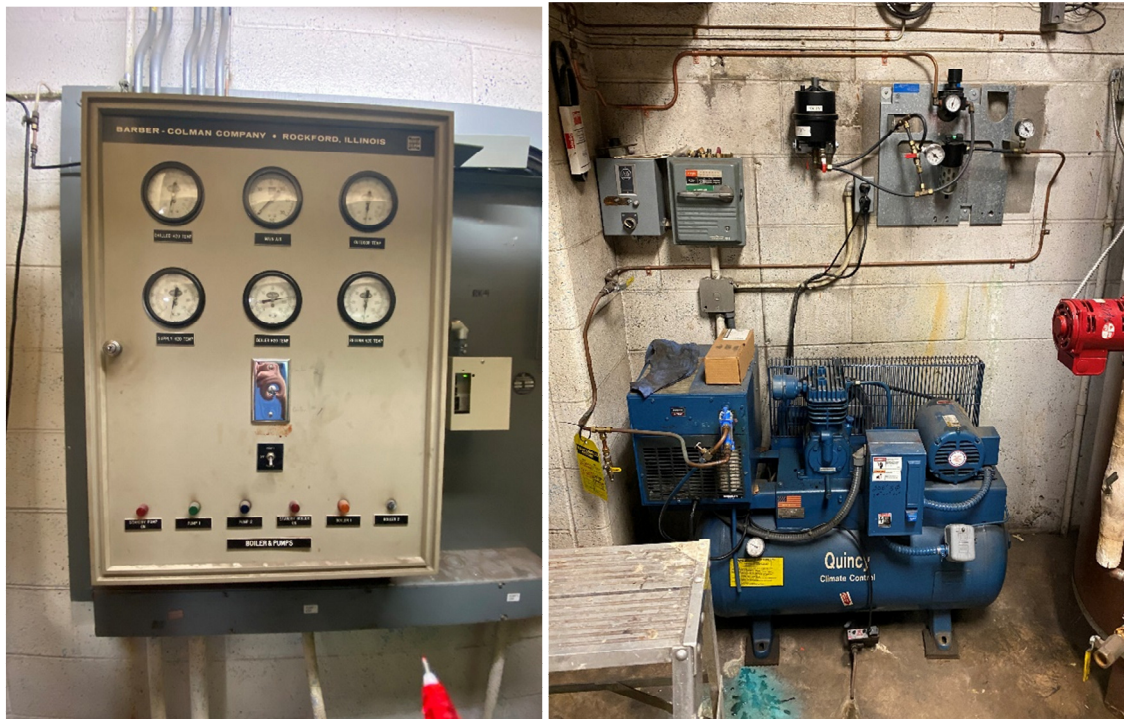
Figure 7 Pneumatic control panel and temperature control air compressor.

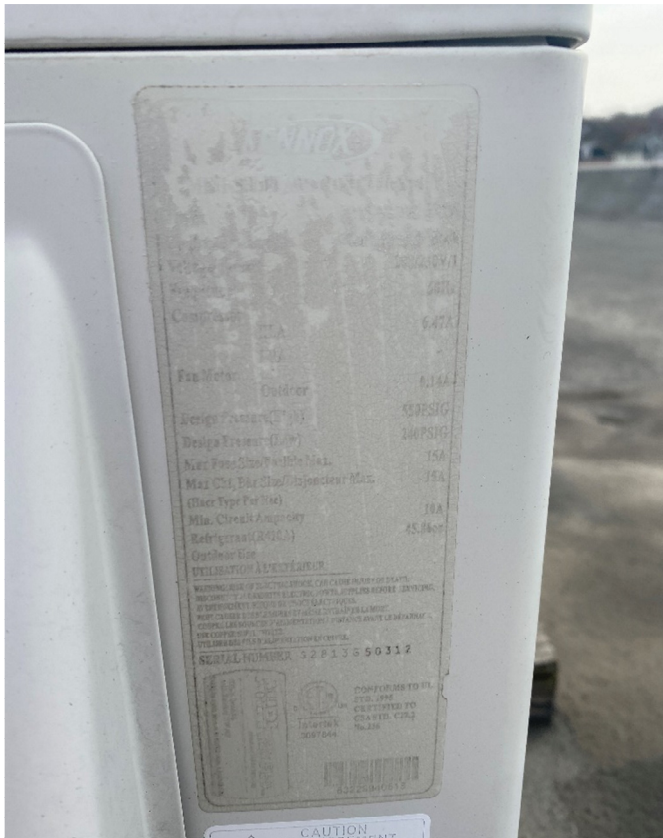
A Lennox ductless split air conditioner was found on the roof and appears to provide additional air conditioning to a computer room or other such space. Although the equipment nameplate was severely faded and could not be read completely, this unit appears to be in operating condition. The serial number indicates that the unit was manufactured in July of 2013. The insulation around the refrigeration piping is damaged by exposure to UV rays and should be repaired. It should be anticipated that this ductless split system will need to be replaced in the next 5-10 years.

Figure 8 Nameplate of ductless split air conditioner.

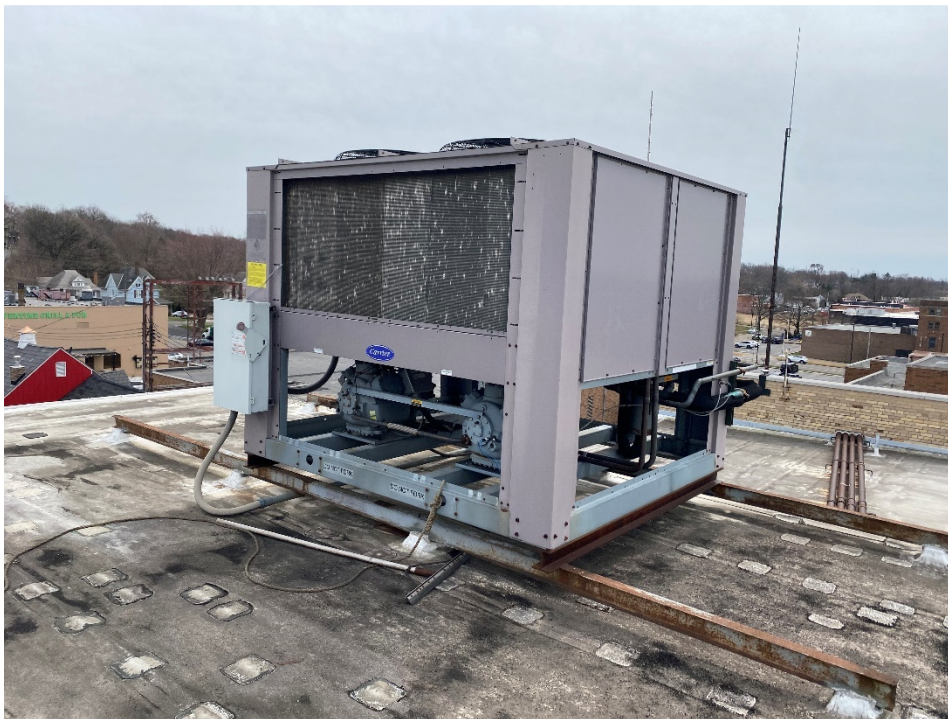
A single, Carrier, air cooled chiller is located on the roof of the bank building. This unit has a capacity of 64 tons and was manufactured on the 28th week of 2009. It has some bent coil fins, probably from a hailstorm and the fins should be straightened with a fin comb. This chiller is in good condition and with continued maintenance last 20 – 25 years.

Figure 9 Bank building chiller.

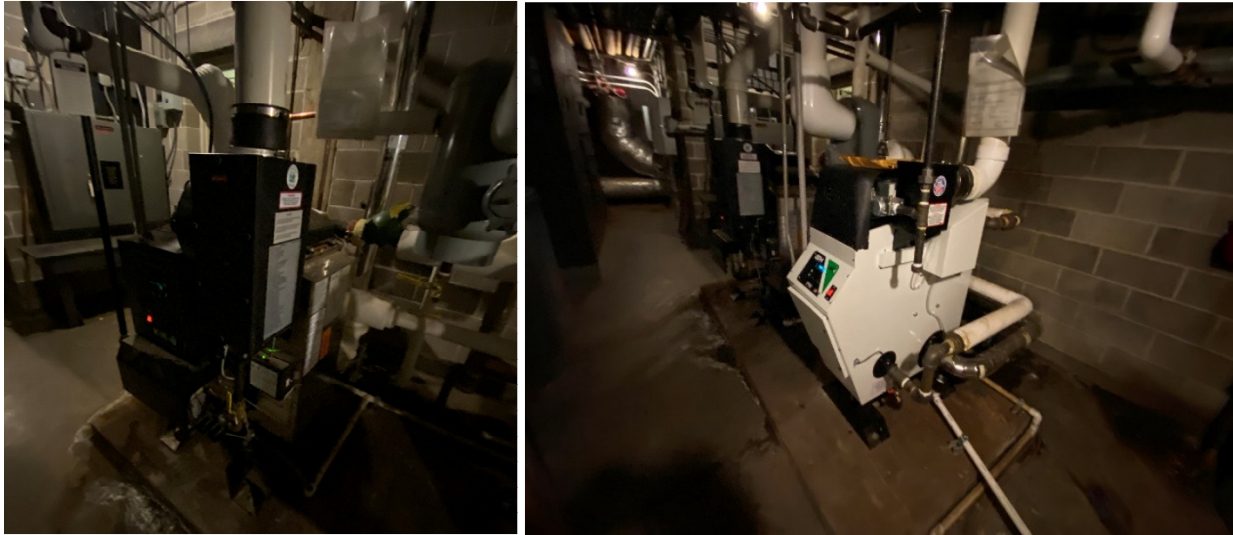
Two, modular, heating hot water boilers are located in the penthouse near the main air handler. Both boilers are manufactured by Hydrotherm. Boiler #1 appears to be 10 years old and Boiler #2 was recently replaced in September of 2020. These boilers appear to be in good condition. Boiler #1 should last another 10 years and Boiler #2 should last 20 years with continued maintenance.

Figure 10 Bank building boilers.

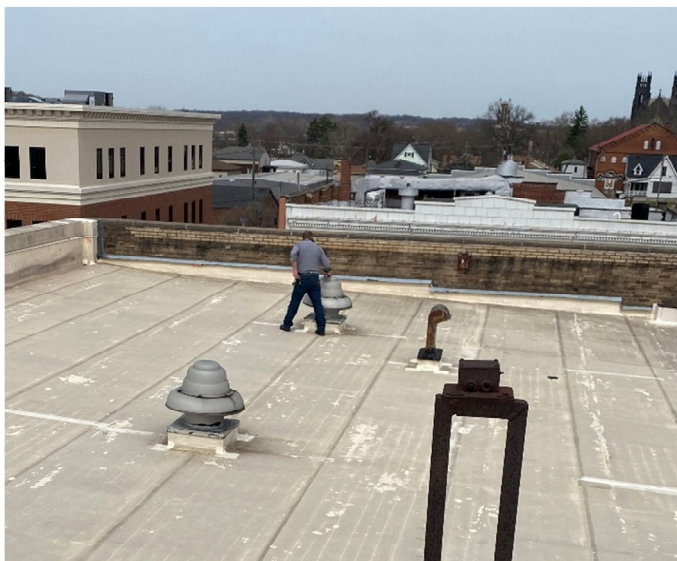
Three exhaust fans were found on the roof of the bank building. The fans are very old, probably from the 60's, in poor condition and not working. According to ASHRAE, the economic life of these exhaust fans is 15-25 years depending on type. All these fans have greatly exceeded their expected life and are due for replacement.

Figure 11 Bank building exhaust fans.

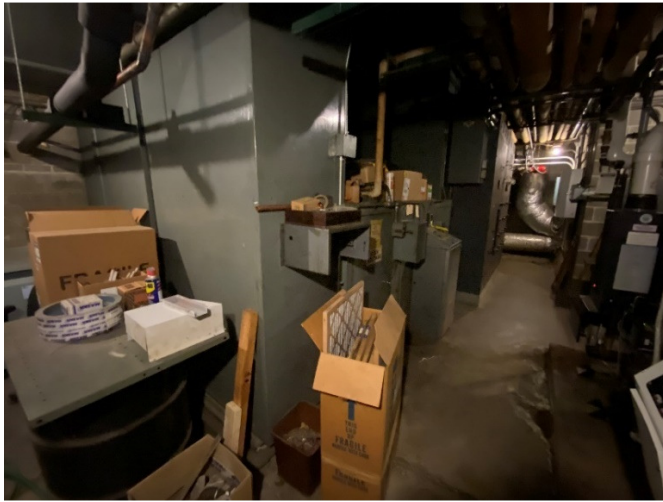
The air handler serving the bank building was built into the structure as the building was constructed. It has a hot deck and cold deck design similar to the multizone air handlers in the municipal building. It has been heavily modified over the years, with the cooling coils replaced and the temperature controls modified and semi-upgraded. There is no manufacturer data plate on the air handler, so the exact age could not be determined. The unit was equipped with a Honeywell electric air cleaner that has been disabled and abandoned in place. While operational, this unit is not very efficient and considerable work has been done to keep it operation well past its economic life. This system is on need of replacement.

Figure 11 Bank building main air handler.

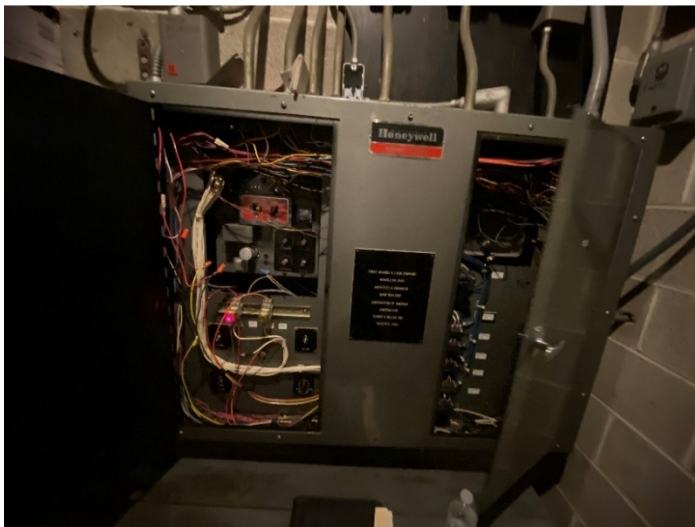
The temperature controls for this building is pretty scary. Most of the controls appear to have been heavily modified several times over the years. These controls are pneumatic and have more than reached the end of their economic life.

Figure 11 Bank building temperature control panel.
